Electrical Short Circuit and Current Overload Tests on Aircraft Wiring

DOT/FAA/CT-TN94/55

1. Report No. DOT/FAA/CT-TN94/55	2. Government Accession No.	3. Recipient's Catalog No.	
4. Title and Subtitle ELECTRICAL SHORT CIRCUIT AND CURRENT OVERLOAD TESTS ON AIRCRAFT WIRING		5. Report Date March 1995

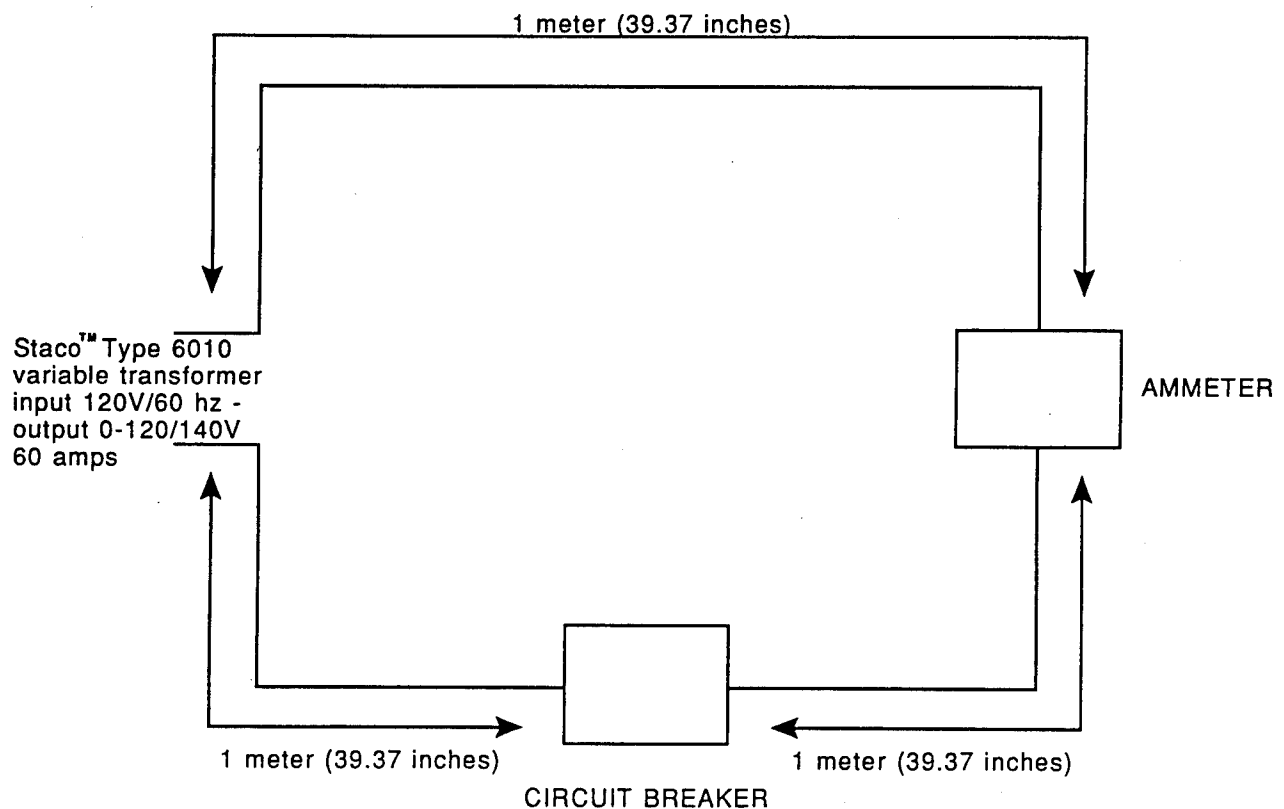
FIGURE 1. TEST CIRCUIT

category aircraft wiring are much higher than the 105°C (221°F) wire specified in the above test method. The use of a 7.5-amp circuit breaker to protect 20 AWG wire was based on aerospace industry testing and computer modeling. This breaker and wire size are also specified in MIL-W-5088 Wiring, Aerospace Vehicle. This specification is approved for use by all departments and agencies of the Department of Defense (DoD). While a 10- and 15-amp circuit breaker would not be used to protect 20 AWG aircraft wiring, this size was selected for testing to determine if any thermal degradation of the insulation occurred that would be apparent or verifiable by microscopic techniques as a result of an overload situation. Table 1 gives the results. The data show that all the breakers tripped well within the one-hour time frame specified in this test method. The wires tested were examined and then cut open to inspect the conductor and other layers of insulation, if applicable, by microscope. There were no signs of degradation internally or externally due to heat such as discoloration, warpage, or embrittlement; and the thermal/acoustic installation showed no signs of heat damage.

All wires were 20 American Wire Gauge (AWG). This gauge was chosen because it is one of the most commonly used sizes. In this test, a 7.5-, 10-, and a 15-amp circuit breaker (all standard aircraft thermal breakers) were subjected to 135 percent of their current rating and time-monitored when the breaker tripped. All tests were conducted at room temperature (23°C, 73°F). Figure 1 shows a diagram of the test circuit. Each wire segment rested on thermal/acoustic insulation (fiber glass with polyester film cover). This test, which is a calibration test used by circuit breaker manufacturers, references the International Electrotechnical Commission (IEC) 934, Circuit Breakers for Equipment, and the Underwriters Laboratories Incorporated (UL) 1077, Supplementary Protectors for use in Electrical Equipment. This test calls for wire rated at 600V and 105°C (221°F). The following is a section of the wire gauge table derived from IEC 934 for this test:

Each of the three test wires was then subjected to current overload without a circuit breaker in-line. Three feet of each wire type (20 AWG) was connected to a variable transformer and placed on thermal/acoustic insulation with polyester film cover. The current for each wire type was determined by previous testing to cause complete thermal degradation of the wires.

Two wires, each three feet long, were connected to a 220V/115V 400-cycle, three-phase generator rated at 18.75 kilo volt amps (kVA); one wire was connected to a "leg" of the wye connection; and one wire was connected to the neutral. This configuration results in a 115V potential (single-phase power) between the two wires. A 7.5-amp aircraft circuit breaker rated at 500 amps of interrupting current at 120V AC-400 Hz was in-line with the "hot" leg. Each of the wires had approximately 1/2 inch of insulation stripped from their ends, and the wire strands were twisted together and suspended vertically with the stripped ends separated approximately one inch. A piece of non fire-retarded polyurethane foam was then placed approximately 1/4 inch behind the two wires. Using a wooden grasping device, the two wires touched intermittently (ticking faults). They were also brought and held together to cause a direct short circuit. This same test was repeated using 208V (phase-to-phase) with a 7.5-amp circuit breaker protecting each leg. Tables 2 and 3 summarize the test results.
